# WATER CHESTNUT HARVEST PROGRAM 2015

Vermont Department of Environmental Conservation  
Montpelier, Vermont

A report on 2015 water  
chestnut mechanical  
and hand harvest  
activities in Lake  
Champlain and other  
waterbodies in Vermont

March 2016

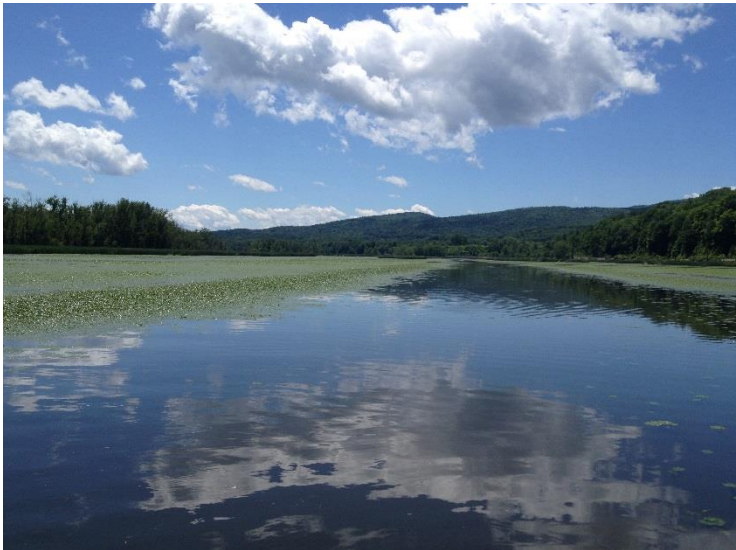
Dense mats of water chestnut flank either side of a boat channel in Lake Champlain, Dresden, NY (VTDEC)

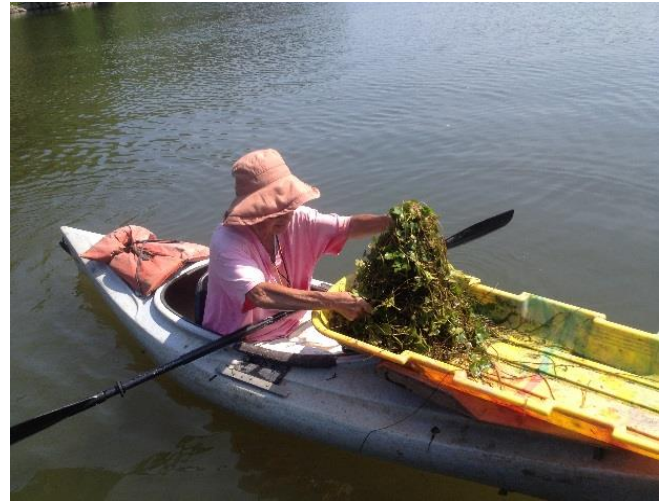
Harvesting water chestnut by kayak (VTDEC)

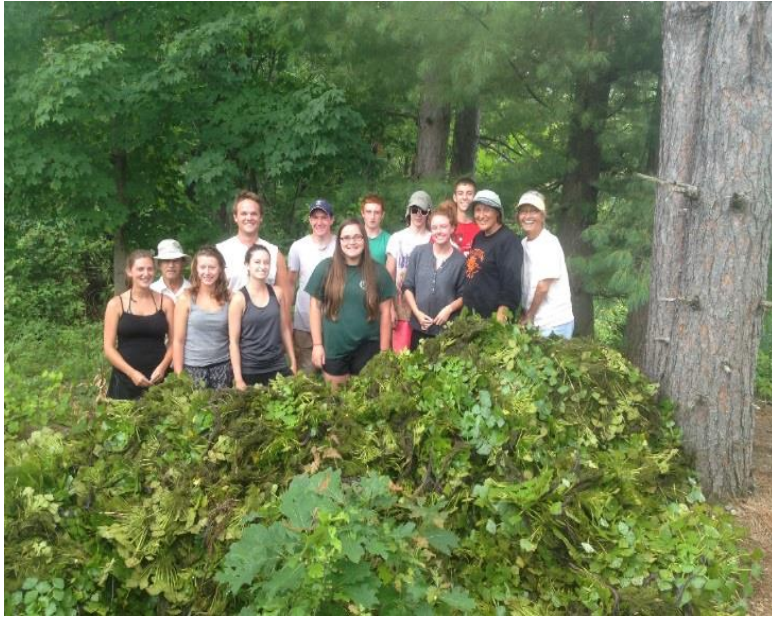
Contracted hand harvest crew with a pile of 44,642 water chestnut rosettes in the foreground, all removed from Blissville wetland pond (VTDEC photo)

Two new other water body sites were discovered in 2015: an unused slate quarry pond in Blissville and Coggman Creek in West Haven. The Blissville pond was confirmed by VTDEC and managed by contracted crews, VTDEC and TNC hand harvesting. An estimated 221,874 water chestnut rosettes weighing over 29,623

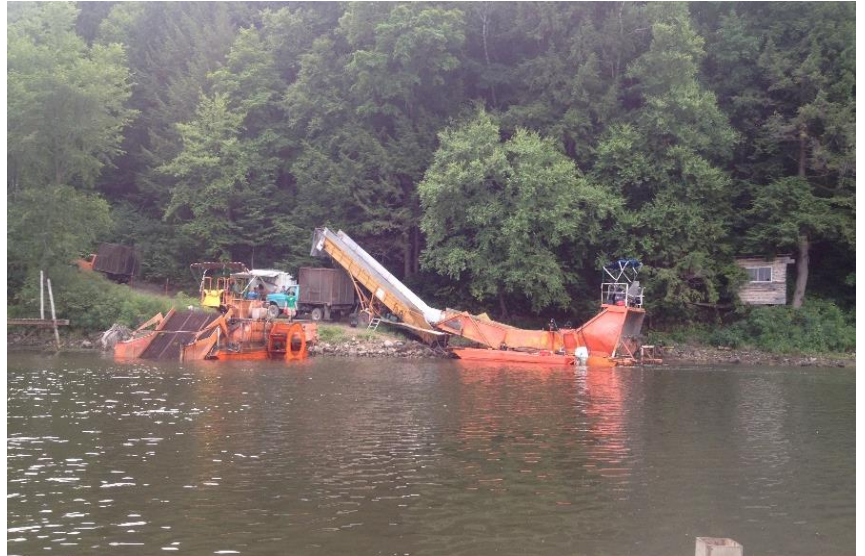
Mechanical harvesting base of operations, Red Rock Bay (VTDEC photo)

- \$1,500 was provided to a private landowner on Red Rock Bay under a memorandum of Understanding for mechanical harvester offloading and site access. This site represents the base of operations for the mechanical harvesting crews and the only offloading site used by the mechanical harvesters in 2015.
- Only minor repairs to a road installed in 2008 under a VTDEC contract were required.

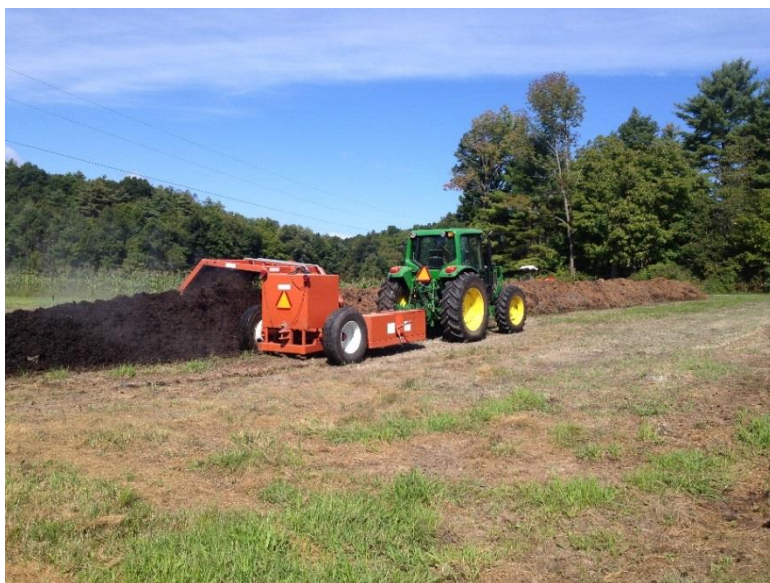
The tractor-pulled compost turner turns a windrow of water chestnut with added bulking agent (VTDEC photo)

- Using a tractor-pulled compost turner, CVCC turned the windrows on October 9<sup>th</sup> to fully incorporate the cow manure and reduce the bulk density to facilitate passive aeration within the windrows.
